# Runabout Rover

**When MG Rover stopped production of the Metro the Rover 200 became the popular small car of choice for several hundred thousand devoted customers and since the sad demise of MG Rover, the franchised dealerships are slowly dwindling, this provides a massive opportunity for independent garages to pick up some of their customers.**

**Professional Motor Mechanic  
February 2006 Issue**

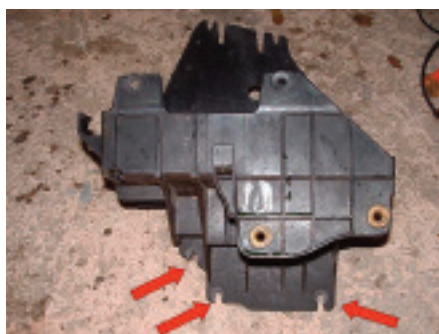
**Fig.1**

The gearbox mounting is hidden underneath the battery tray so you will have to remove the battery, ECU, relay module, resonator (bolted to the battery tray) and the three bolts hidden underneath the battery tray (fig.1) before the battery tray will come out. Disconnect the clutch cable and stow to one side. Disconnect the multiplug from the reverse light switch and the vehicle speed sensor. Disconnect the gear selector ball joints from the gearbox using a suitable 2 pronged tool that will not damage the sockets. Unbolt the clutch cable support bracket

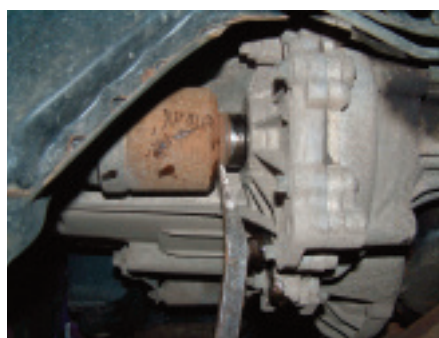
**Fig.2**

Raise the vehicle in the air and drain the gearbox oil into a suitable container. Release the driveshaft inner joints, ready for removal later using a suitable tool (fig.2) taking care not to damage the gearbox casing or the driveshaft oil seals. Remove the starter motor bolts and its support

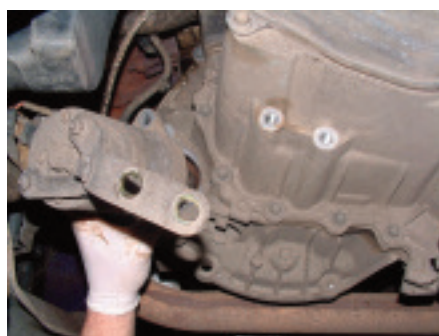
**Fig.3**

bracket (fig.3) and stow securely besides the radiator. Remove the lower gearbox closing plate and the bolts securing the front closing plate to the gearbox bell housing.

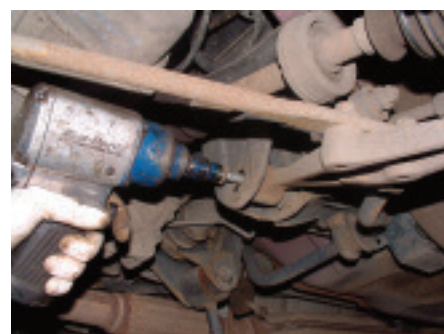
**Fig.4**

Remove the N/S lower suspension arm pivot bolt (fig.4). To gain access to the N/S tie rod nut in the front beam with an air gun (fig.5), you will need to lower the O/S of the front beam as the bumper is in

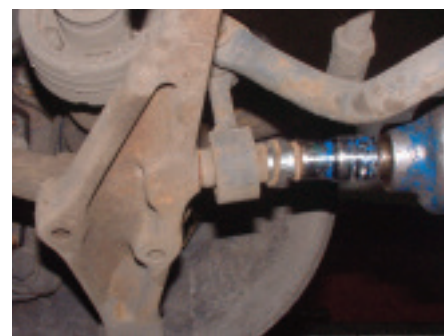
**Fig.6**

the way, by removing the two N/S bolts and slackening the two bolts on the O/S, the beam will drop low enough for access. However, you can gain access with a normal long reach socket and ratchet without dropping the beam. Disconnect the roll bar link (fig.6) from N/S lower arm. Lower the lower arm from the pivot bolt bracket, pull rearwards to remove the tie rod from the front beam and carefully remove the N/S

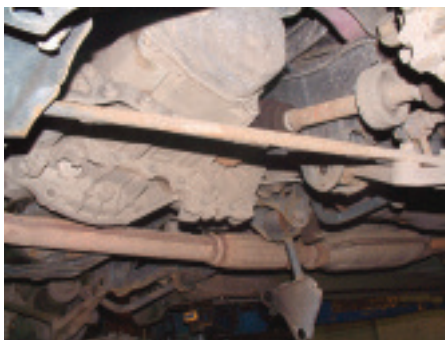
**Fig.7**

driveshaft taking care not to damage the oil seal. Slacken the engine steady bar to body bracket bolt (fig.7) and remove the steady bar to gearbox bolt.

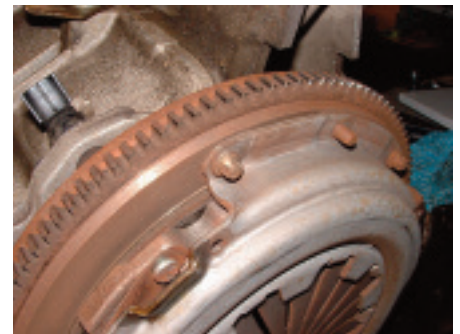
**Fig.8**

Remove the old clutch using a Torx socket (fig.8), always remove any debris and check the condition of the flywheel. Check for signs of oil leakage from the rear crank seal and remove the flywheel and replace it if necessary. Check the condition of the gearbox dowels and replace if they are damaged. The new clutch can be bolted on evenly and sequentially using an appropriate alignment tool to centre the plate.
